**TRANSPORTATION SCIENCES
CRASH DATA RESEARCH CENTER**

**VERIDIAN ON-SITE
SIDE IMPACT CURTAIN DEPLOYMENT FATALITY /
EVENT DATA RECORDER EQUIPPED VEHICLE INVESTIGATION**

VERIDIAN CASE NO. CA01-044

VEHICLE - 2001 SATURN SL1

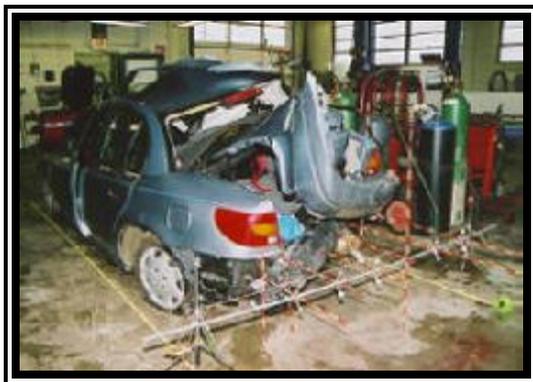
The 2001 Saturn SL1 sustained severe damage as a result of the initial rear-end impact with the (V1) 2001 Ford Explorer Sport-Trac (**Figures 10 & 11**). The direct contact damage began at the rear right bumper corner and extended 95.0 cm (37.4 in) inboard. The impact deformed the entire rear end width resulting in a combined direct and induced damage length (Field L) of 127.0 cm (50.0 in). Six crush measurements were documented at the level of the reinforcement bar (*bumper fascia separation*): C1= 1.5 cm (0.6 in), C2= 14.5 cm (5.7 in), C3= 25.5 cm (10.0 in), C4= 39.5 cm (15.6 in), C5= 54.5 cm (21.5 in), C6= 56.5 cm (22.2 in). The Collision Deformation Classification (CDC) for this initial impact to the Saturn was 06-BZEW-6 with a principal direction of force of 180 degrees. Light colored paint transfers were documented along the direct contact damage. The backlight glazing was disintegrated as the trunk lid was displaced up and forward from the impact force. Induced contact damage produced extensive buckling along the rear header and right side pillars (roof glazing disintegrated). Both quarter panels were deformed forward which restricted the rear doors and the right rear wheel/tire (not deflated). Reduction in the right side wheelbase measured 17.0 cm (6.7 in) as elongation in the left side wheelbase measured 7.0 cm (2.8 in).

Figure 10. Rear right damage to the 2001 Saturn SL1 4-door sedan (V2).

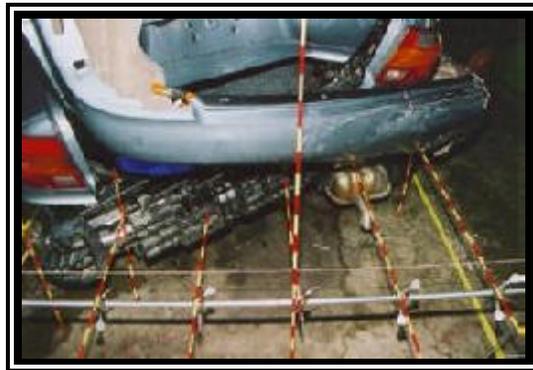
Figure 11. Contour gauge overview of the rear end structure (impact #1).

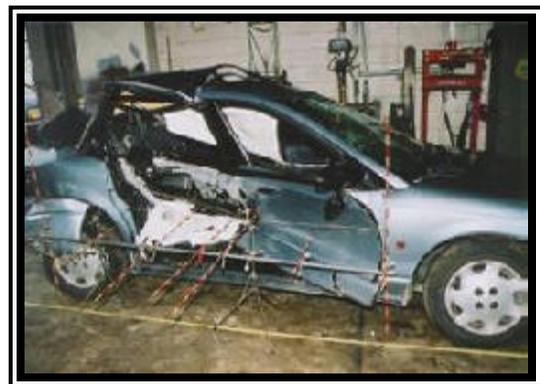
Direct contact damage was also identified to the right side surface attributed to the secondary impact with the (V3) 2001 GMC Yukon SLT (**Figure 12**). The direct contact damage began 69.0 cm (27.2 in) aft of the right front axle and extended 148.0 cm (58.3 in) rearward. The combined direct and induced damage length (Field L) began 52.0 cm (20.5 in) aft of the right front axle and extended 205.0 cm (80.7 in) rearward. The stand offset method was utilized as six crush measurements were documented at the level of the mid-door: C1= 0 cm, C2= 10.0 cm (3.9 in), C3= 52.0 cm (20.5 in), C4= 50.0 cm (19.7 in), C5= 26.0 cm (10.2 in), C6= 0 cm. A maximum crush value of 61.0 cm (24.0 in) was documented 27.5 cm (10.8 in) forward of the C3 position. A secondary profile was obtained at the level of the sill to capture the B-pillar separation (door support failure) resulting in an *averaged profile* of: C1= 0 cm, C2= 10.0 cm (3.9 in), C3= 42.0 cm (16.5 in), C4= 38.0 cm (15.0 in), C5= 26.0 cm (10.2 in), C6= 0 cm. The CDC for this secondary impact to the Saturn was 04-RZAW-4 with a principal direction of

Figure 12. Impact #2 right side surface damage to the 2001 Saturn SL1 4-door sedan (V2) .

force of (+)120 degrees. The direct contact damage extended vertically above the beltline to the upper B-pillar area. Right B-pillar failure at the level of the lower sill allowed for extensive intrusion of interior components. The right side tempered glazings were disintegrated as the windshield fractured along the upper header and lower right A-pillar areas from exterior impact forces. Induced contact damage produced additional roof buckling along the right side pillars. Both left side tires were deflated (not restricted) with soil deposits noted in the wheels.

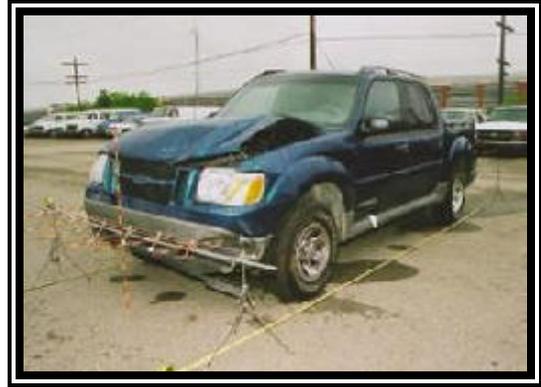
The 2001 Ford Explorer Sport-Trac 4x4 sustained moderate (*overlapping*) damage as a result of the impact with the 2001 Saturn SL1 (V2) and the 2000 Chevrolet Silverado (V4) pickup truck (**Figure 13**). Pronounced and contrasting paint transfers allowed for the identification of separate direct damaged areas for accurate assignment of CDC's. The direct contact damage attributed to the initial impact with the Saturn began at the front left bumper corner and extended 84.0 cm (33.1 in) inboard. The CDC assigned to this impact was 12-FYEW-1 with a principal direction of force of 0 degrees.

Figure 13. Overlapping frontal damage to the 2001 Ford Explorer Sport-Trac 4x4 (V1).

The direct contact damage attributed to the secondary impact with the Chevrolet began at the front left bumper corner and extended 111.0 cm (43.7 in) inboard. The CDC assigned to this secondary impact was 12-FDEW-1 with a principal direction of force of 0 degrees. The impacts deformed the entire front end width resulting in a combined direct and induced damage length (Field L) of 139.0 cm (54.7 in). Overlapping protocol was utilized as six crush measurements were documented at the level of the bumper: C1= 11.0 cm (4.3 in), C2= 3.0 cm (1.2 in), C3= 2.0 cm (0.8 in), C4= 1.0 cm (0.4 in), C5= 1.0 cm (0.4 in), C6= 0 cm. Black paint transfers were identified along the front left bumper area and attributed to the secondary impact with the Chevrolet. White/gray paint transfers were identified along the front left bumper/hood areas and attributed to the initial impact with the Saturn. The hood was deformed up and rearward from engagement against the rear end structures of the Saturn and Chevrolet. The grille assembly remained undamaged. The windshield was fractured at the lower left A-pillar and attributed to the initial impact with the Saturn. No wheelbase reduction, bed to cab contact, or roof buckle was identified.

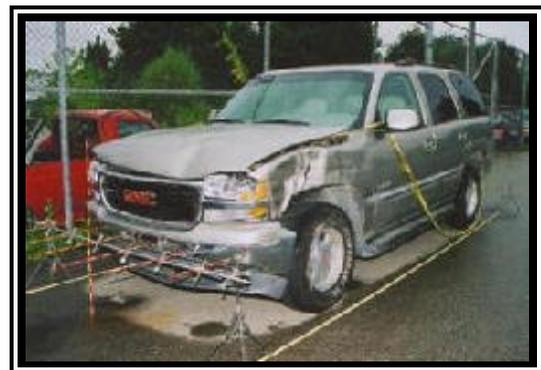
The 2001 GMC Yukon SLT 4x4 sport utility vehicle sustained minor frontal damage as a result of the impact with the (V2) 2001 Saturn SL1 (**Figure 14**). Although the obtuse angle impact configuration resulted in primary engagement along the front left and center sections of the end structure, subsequent (clockwise) wrap contact by the Saturn produced additional direct contact damage along the remainder of the front end width, resulting in a combined direct and induced damage length (Field L) of 168.0 cm (66.1 in). Six

Figure 14. Frontal damage to the 2001 GMC Yukon SLT 4x4 sport utility vehicle (V3).

crush measurements were documented at the level of the bumper: C1= 10.0 cm (3.9 in), C2= 3.0 cm (1.2 in), C3= 2.0 cm (0.8 in), C4= 2.0 cm (0.8 in), C5= 3.0 cm (1.2 in), C6= 4.0 cm (1.6 in). The CDC for this impact to the GMC was 12-FDEW-1 with a principal direction of force of (-)10 degrees. White/gray paint transfers were documented along the direct contact damage. The left headlight was fractured as the left tow hook was displaced rearward approximately 3.8 cm (1.5 in). Two pronounced indentations were noted to the leading edge of the hood and attributed to the right side B and C-pillars on the Saturn. Left side wheelbase reduction measured 2.0 cm (0.8 in). The windshield and all tempered glazings remained undamaged.

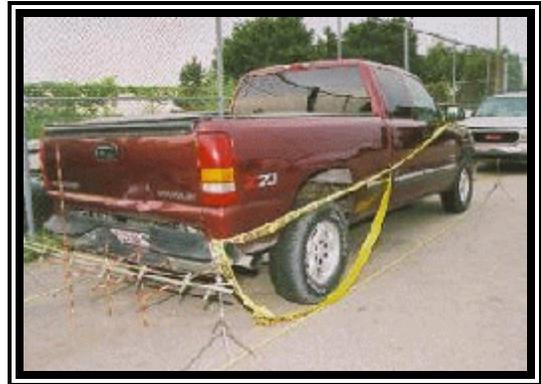
The 2000 Chevrolet K-1500 Silverado 4x4 pickup truck sustained minor rear damage as a result of the impact with the (V1) 2001 Ford Explorer Sport-Trac (**Figure 15**). The direct contact damage began 25.0 cm (9.8 in) inboard of the rear left bumper corner and extended right 114.0 cm (44.9 in). The impact deformed the entire rear end width resulting in a combined direct and induced damage length (Field L) of 173.0 cm (68.1 in). Six crush measurements were documented at the level of the bumper: C1= 17.0 cm (6.7 in), C2= 17.0 cm (6.7 in), C3= 16.0 cm (6.3 in), C4= 16.0 cm (6.3 in), C5= 15.0 cm (5.9 in), C6= 15.0

Figure 15. Rear damage to the 2000 Chevrolet K-1500 4x4 pickup truck. (V4)

cm (5.9 in). The CDC for this impact to the Chevrolet was 06-BDEW-1 with a principal direction of force of 180 degrees. Blue/white paint transfers were documented along the direct contact damage and tailgate. Minor bed to cab contact was noted on both sides. No wheelbase reduction was identified.

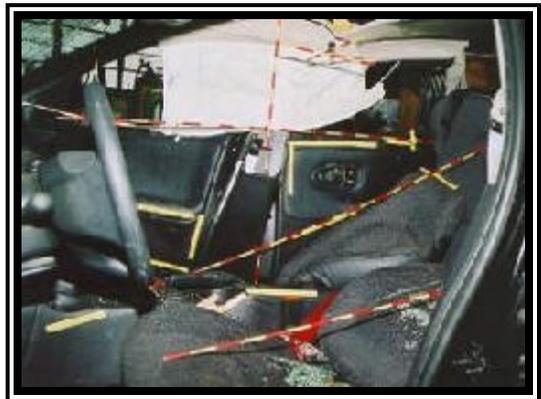
Interior damage to the Saturn was severe and was attributed to component intrusions and occupant contact (**Figure 16**). Extensive indentations were identified along the right lower interior surface. Scuff marks, small indentations, and skin tissue were documented on the right rear armrest with the door hardware displaced inward. Both front seat backs were deformed rearward by occupant loading, and attributed to the initial rear-end impact. The front seat backs were deformed beyond a rearward mid-range position and displaced against the rear seat cushion. The front left and right seat backs were respectively *unrestricted* and *restricted* in this deformed reclined position with prevalent displacement of the frame and failure of both seat back recline adjustment mechanisms noted. Intrusion of lateral components and driver loading during the secondary right side impact produced additional deformation to the lateral aspects of the front right seat back. Lateral displacement

Figure 16. Interior view of the 2001 Saturn SL1 (V2).

of the floor mounted transmission lever, console, and parking brake were identified. Lateral intrusions into the right occupant spaces involved 40.0 cm (15.7 in) of rear door/window frame, 40.0 cm (15.7 in) of B-pillar, 35.0 cm (13.8 in) of front door/window frame, 29.0 cm (11.4 in) of front/rear sill, 26.0 cm (10.2 in) of rear roof side rail, and 17.0 cm (6.7 in) of front roof side rail intrusion.

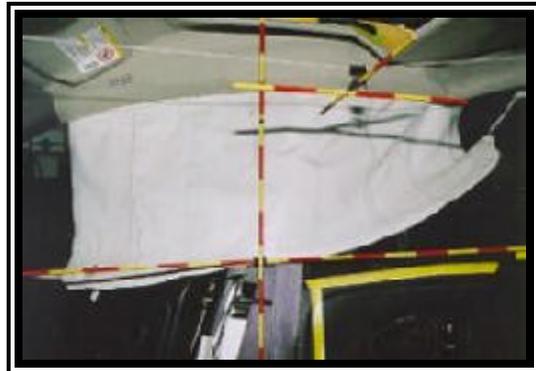
The Saturn was also equipped with side impact curtains for the outboard seating positions. The right side impact curtain deployed as a result of the impact with the (V3) 2001 GMC Yukon (**Figure 17**). The side curtain air bag was housed between the interior roof headliner and structural roof side rail with a horizontal seam measuring 143.0 cm (56.3 in) in length (separation of the headliner versus an actual flap). Inflation was achieved by the use of a cold gas (stored) inflator located in the C-pillar. The air bag measured 84.0 cm (33.1 in) in width and 34.0 cm (13.4 in) in height in its deflated state. The air bag was tethered by 22.0 cm (8.7 in) external straps connected to the left A-pillar and left rear roof side rail. No vent ports were present. No contact evidence was identified to the air bag.

Figure 17. 2001 Saturn SL1 (V2) deployed right side impact curtain.

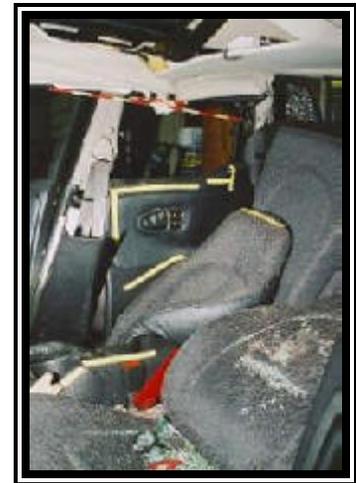
At impact with the 2001 GMC Yukon SLT (V3), the passenger was displaced rearward (out-of-position) in a reclined posture. She initiated a lateral/slightly rearward trajectory in response to the 4 o'clock impact force and loaded the right side interior surface (**Figure 18**). Head contact to the right rear door interior surface resulted in a subarachnoid hemorrhage as evidenced by the skin tissue and indentations documented on this component. Indentations along the lower doors and B-pillar clearly outlined lower extremity and pelvic regions. This distinct contact pattern further confirmed the passenger's abnormal posture as a result of the seat back recline adjustment mechanism failure. At this point, the driver entered the passenger space and compressed the passenger against the right B-pillar and door interior surface resulting in a multitude of soft tissue injury and internal trauma. This occupant-to-occupant contact resulted in multiple left side abrasions and contusions along with fractures of the left 3rd - 7th ribs. These injury mechanisms were evidenced by the extensive deformation identified on the center console and front right seat back from driver loading. Passenger compression against the right B-pillar and interior surface resulted in additional fractures of the right 1st - 10th posterior ribs and underlying critical bilateral lung contusions and lacerations. Additional internal trauma included unspecified lacerations of the liver/spleen along with ruptures of the diaphragm and *adjacent* inferior vena cava. During post-impact trajectory to final rest, she initiated a lateral response to the left and came to rest in the prone position (on top of the driver's lower extremities) with her head/torso laterally across the center console and forward edge of the seat cushions. Although death was probably immediate, the passenger was removed by rescue personnel through the left front door in an unconscious state, and subsequently transported by ambulance to a local trauma center where she was pronounced deceased shortly after arrival. The failure of the seat back recline adjustment mechanism mitigated the effectiveness of the deployed right side impact curtain by allowing for an abnormal posture for the subsequent right side impact, and thus, provided no crash protection to the front right passenger.

Figure 18. Passenger contact evidence to the right side interior surface.

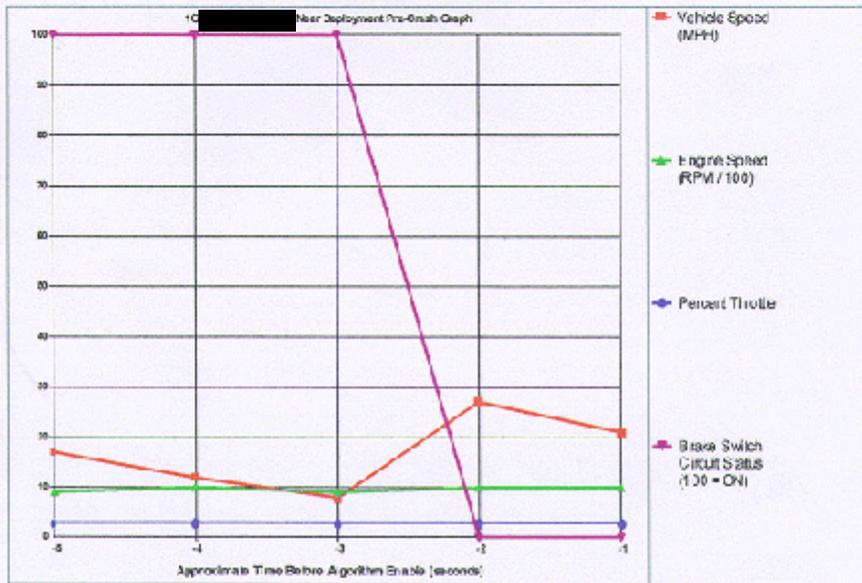
Figure 20. (V2) 2001 Saturn SL1 EDR report.

Data Recorder (EDR) records deployment and near-deployment events for the frontal air bag system. In this crash, the EDR recorded a near deployment event at ignition cycle number 1028 (*ignition cycles at investigation were 1030*). The system status at near deployment reflected the driver's belt switch circuit status as "unbuckled". As the vehicle and engine speed decreased during the first three seconds of the five second pre-crash interval, the brake switch circuit status went from "on" to "off" three seconds prior to algorithm activation. At the two second pre-crash interval, the vehicle's speed rapidly accelerated from 12.9 km/h (8.0 mph) to 43.5 km/h (27.0 mph), indicative of an impact induced velocity change. The vehicle's speed dropped to 33.8 km/h (21.0 mph) one second prior to algorithm activation.

SIR Warning Lamp Status	OFF
Driver's Belt Switch Circuit Status	UNBUCKLED
Passenger Front Air Bag Suppression Switch Circuit Status	Air Bag Not Suppressed
Ignition Cycles At Near Deployment	1028
Ignition Cycles At Investigation	1030
Maximum SDM Recorded Velocity Change (MPH)	1080
Algorithm Enable to Maximum SDM Recorded Velocity Change (msec)	7.5

Seconds Before AE	Vehicle Speed (MPH)	Engine Speed (RPM)	Percent Throttle	Brake Switch Circuit Status
-5	17	896	3	ON
-4	12	880	3	ON
-3	5	806	3	ON
-2	27	960	3	OFF
-1	21	960	3	OFF

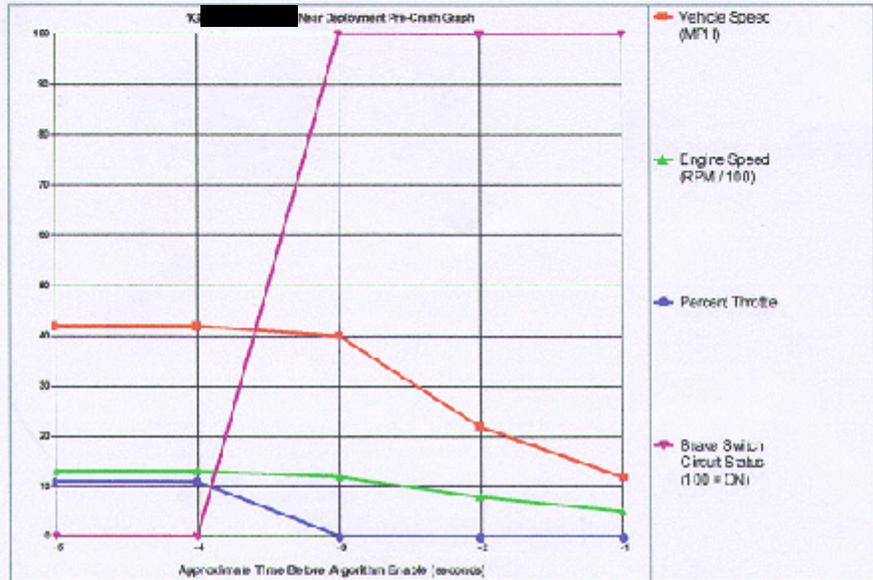
Figure 21. (V3) 2001 GMC Yukon SLT 4x4 EDR report.

The 2001 GMC Yukon SLT SDM was located under the driver's seat as the event data was retrieved via the J1962 connector found to the left of the steering column. The EDR records deployment and near-deployment events for the frontal air bag system. In this crash, the EDR recorded a near deployment event at ignition cycle number 486. The system status at near deployment reflected the driver's belt switch circuit status as "unbuckled". As the vehicle and engine speed decreased from 67.6 km/h (42.0 mph) to 19.3 km/h (12.0 mph) during the five second pre-crash interval, the brake switch circuit status went from "off" to "on" three seconds prior to algorithm activation.

SIR Warning Lamp Status	OFF
Driver's Belt Switch Circuit Status	UNBUCKLED
Passenger Front Air Bag Suppression Switch Circuit Status	Air Bag Not Suppressed
Ignition Cycles At Near Deployment	466

Seconds Before AE	Vehicle Speed (MPH)	Engine Speed (RPM)	Percent Throttle	Brake Switch Circuit Status
-5	42	1344	11	OFF
-4	42	1344	11	OFF
-3	40	1352	0	ON
-2	22	700	0	ON
-1	12	512	0	ON

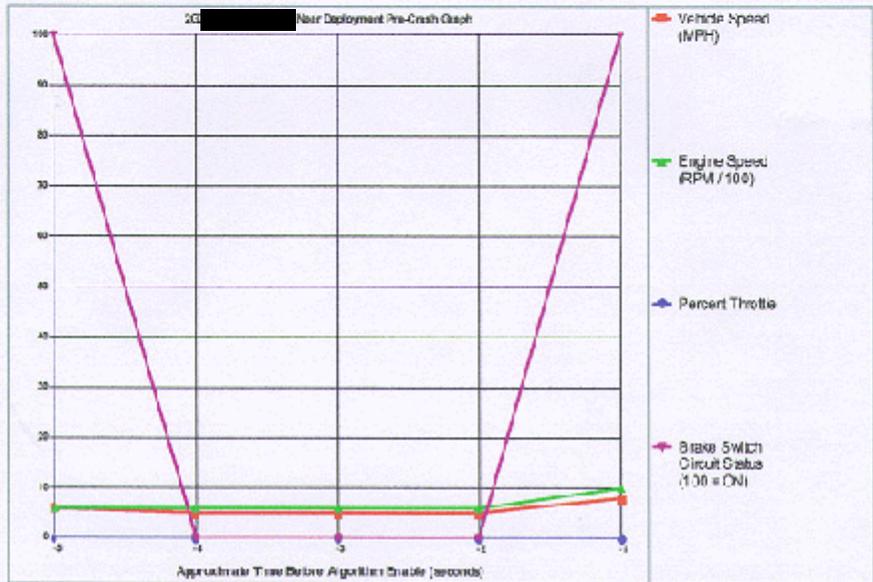
Figure 22. (V4) 2000 Chevrolet K-1500 4x4 pickup truck EDR report.

The 2000 Chevrolet K-1500 Silverado pickup truck SDM was located under the driver's seat as the data was retrieved via the J1962 connector found to the left of the steering column. The EDR records deployment and near-deployment events for the frontal air bag system. In this crash, the EDR recorded a near deployment event at ignition cycle number 1532. The system status at near deployment reflected the driver's belt switch circuit status as "unbuckled". As the vehicle and engine speed fluctuated from 8.0 km/h (5.0 mph) to 12.9 km/h (8.0 mph) during the five second pre-crash interval, the brake switch circuit status repeatedly went from "on" to "off", indicative of two foot ("*feathered*") operation of the (automatic transmission) accelerator and brake pedals.

SIR Warning Lamp Status	OFF
Driver's Belt Switch Circuit Status	UNBUCKLED
Passenger Front Air Bag Suppression Switch Circuit Status	Air Bag Suppressed
Ignition Cycles At Near Deployment	1532

Seconds Before AE	Vehicle Speed (MPH)	Engine Speed (RPM)	Percent Throttle	Brake Switch Circuit Status
-5	6	610	0	ON
-4	5	640	0	OFF
-3	5	640	0	OFF
-2	5	640	0	OFF
-1	6	600	0	ON
